Potential Causes of Failure in an Aluminum Sand-Cast Pot from Zambia

Abstract—An investigation into the failure of sand cast aluminum pots was conducted. These pots were made with recycled aluminum by a small business in Zambia. The most common failure mode of these pots is the legs breaking off in a brittle manner. Three possible causes of failure were explored: impurities (particularly iron) in the microstructure, gas porosity caused by poor casting methods, and the geometry of the pot. Based off EDS and SEM results, tensile testing on cast dogbones, and SolidWorks finite element analysis, the geometry of the pot is the most likely cause of this problem.

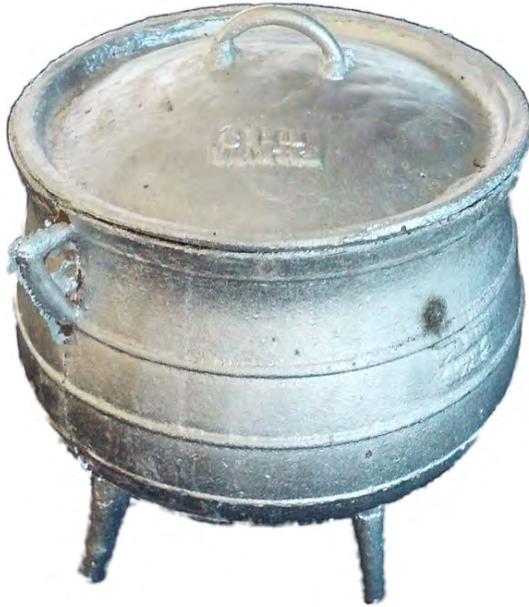
Fig. 1. The Zambian pot being analyzed.

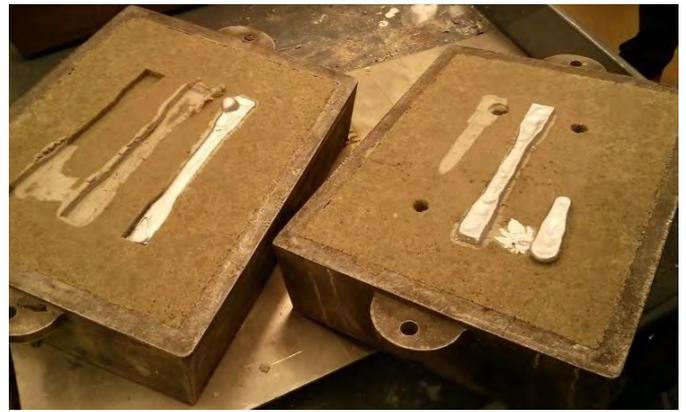
A sand casting flask was used to create the two-part mold for the dog bones. Sand was mixed with bentonite clay powder and water to create a sticky, densely packed material for the mold. On one side of the mold, the sand mixture was pressed around nylon sample dog bones, then the nylon dog bones were removed to create -shaped cavities. On the other side

Fig. 3. The mold and sand cast dog bones

of the mold, the sand mixture was pressed around a set of wax conical sprues and cylindrical sprues. The sprues were carefully aligned to create passages for the liquid metal to enter the on the first half of the mold, and to create vents for air in the mold to escape.

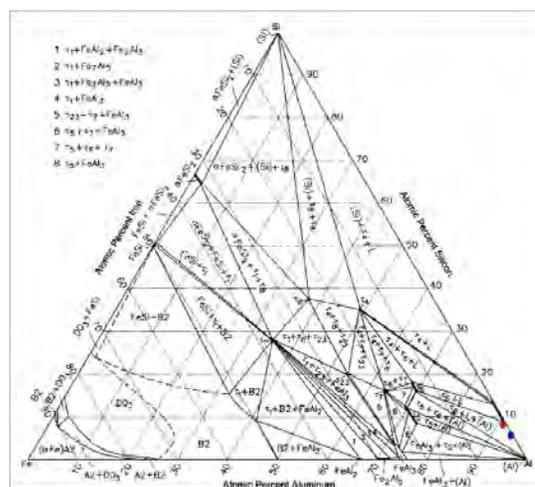
The pot sample has far fewer impurities than expected for recycled aluminum, and nearly matches industrial alloy A03320. Alloys A356 and A03320 fall into the same area of the ternary phase diagram for Al-Si-Fe as shown in Figure 11.

At 600°C, the phases present in both alloys include liquid and τ_6 ($Al_{4.5}SiFe$), also known as the beta phase. The stock aluminum sample also contains a primary aluminum (Al) phase, while the pot sample falls approximately on the line between the L + τ_6 + (Al) phase and the L + τ_6 . This could explain the apparent absence of (Al) in the images of the pot sample.

Fig. 11. Al-Si-Fe phase diagram at 600°C. Alloy A356 is represented by the blue dot, and A03320 is represented by the red. Modified from [4].

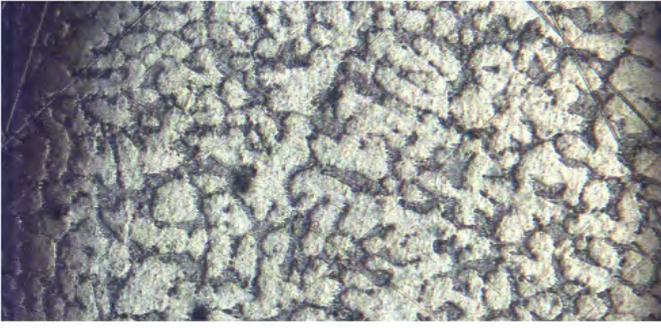
Though the two samples (Figures 12 and 13) look very different because of the lack of (Al) phase in the pot, they are quite similar in composition. With the professional analysis of composition showing the pot sample to be in the acceptable ranges of all impurities and the results of testing on casted dog bones, it was finally concluded that iron content is most likely not the underlying cause of failure.

Fig. 12. The commercial Al-Si alloy at 200x magnification.
